Repairability analysis of the energy gas turbine rotor blade second stage shroud by high-temperature brazing

Abstract: The article considers the repair of the energy gas turbine rotor blade second stage shroud. The paper presents an analysis of the possibility of the repair consisting of the replacement of both labyrinth and honeycomb seals by the high-temperature brazing process. All the steps of the repair process were discussed and the results of microscopic metallographic evaluation using a light microscope and a scanning electron microscope were presented. SEM BSE microstructure and elements distribution of the joints has been presented. Several advantages related to the use of this technology were indicated.

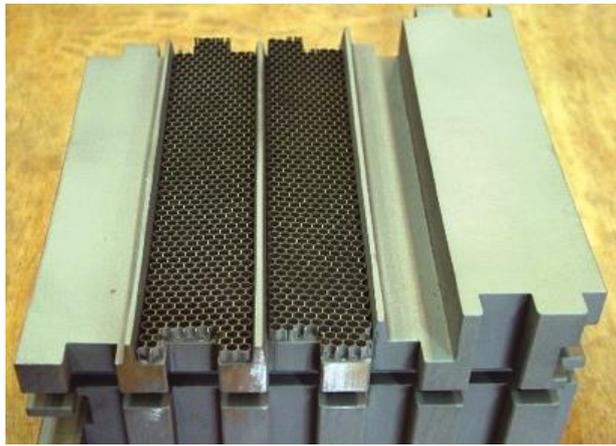
Fig. 1. Gas turbine second stage rotor blade shroud MS6001

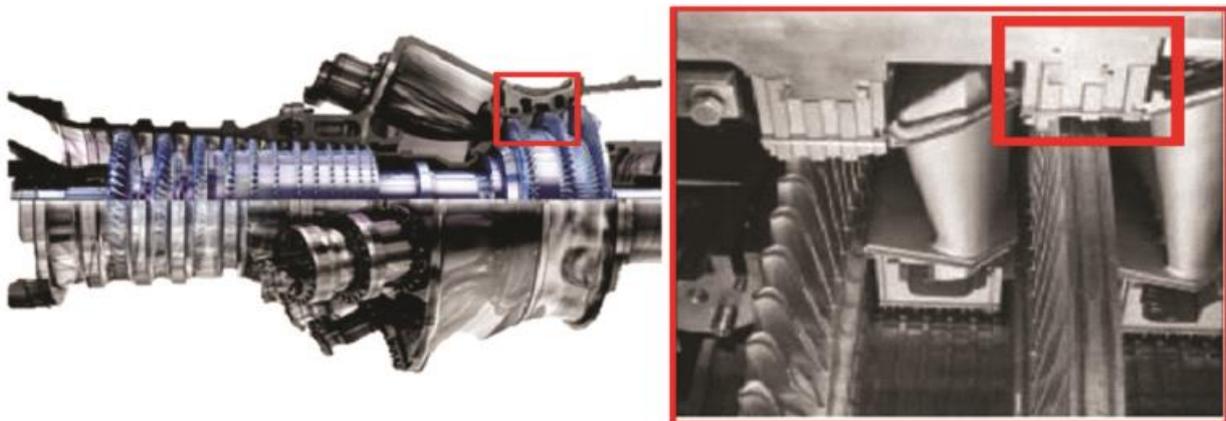
Fig. 2. Second stage rotor blade shroud location in a gas turbine [8]

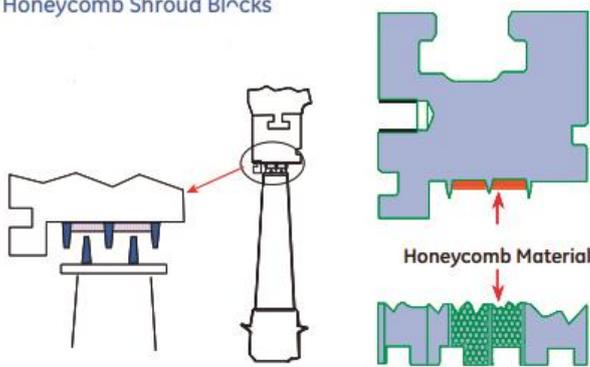
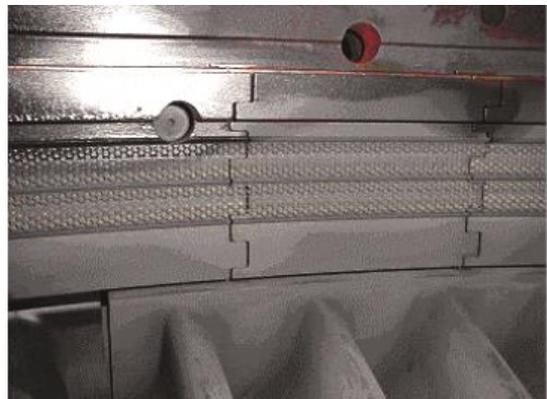
Fig. 3. Diagram of a labyrinth seal in combination with a honeycomb seal at the junction of the second stage of the rotor blade and its shroud [12]

Depending on the degree of the turbine blade and the type of its shroud, different types of seals are used. One of the types of sealing used in both aircraft engines and gas turbines is a combination of a labyrinth seal and a honeycomb seal [9] (Fig. 3).

The higher pressure ratio and the economical use of the cooling air require a low ground clearance, with the risk of contact and abrasion of the sealing surfaces. The use of a honeycomb seal in combination with a labyrinth seal allows for minimal leakage, tolerating to some extent abrasion [10]. The advantage of honeycomb seals over other solutions is also that the individual honeycomb cells act as low-pressure gas-compressing elements. The gas seal phenomenon is that the gases flowing through the honeycomb seal are inhibited by the capillary walls, reflect off them and create additional resistance to the flowing air. As a result, the phenomenon of dynamic gas sealing of the engine is observed [11]. During operation of the turbine, the sealing surfaces are exposed to a number of factors causing wear. One of them is high-temperature corrosion caused by the action of a stream of hot, pressurized exhaust gases. As a consequence, the thickness of the sealing surfaces is reduced, and the labyrinth seals are cracked as a result of thermo-mechanical fatigue. In extreme cases, we can also deal with friction of the sealing surfaces. Repairing the rotor's blade shroud requires not only replacing the honeycomb seal, but also rebuilding the edge of the labyrinth seal. One of the methods used to rebuild the shape of a labyrinth seal is manual TIG

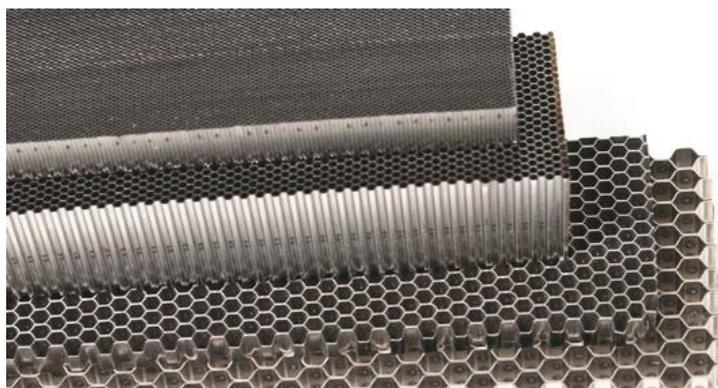
Fig. 4. The examples of honey-comb seals [www.indyhoneycomb.com/engine-seal-honeycomb]

Honeycomb seals (Fig. 4) used in the rotor's casings of the blades are usually made of nickel alloys with the trade name Hastelloy X or Haynes 214, characterized by high resistance to oxidation and maintaining strength properties at temperatures up to 1200 °C [14]. The chemical composition of these alloys is given in Table II.

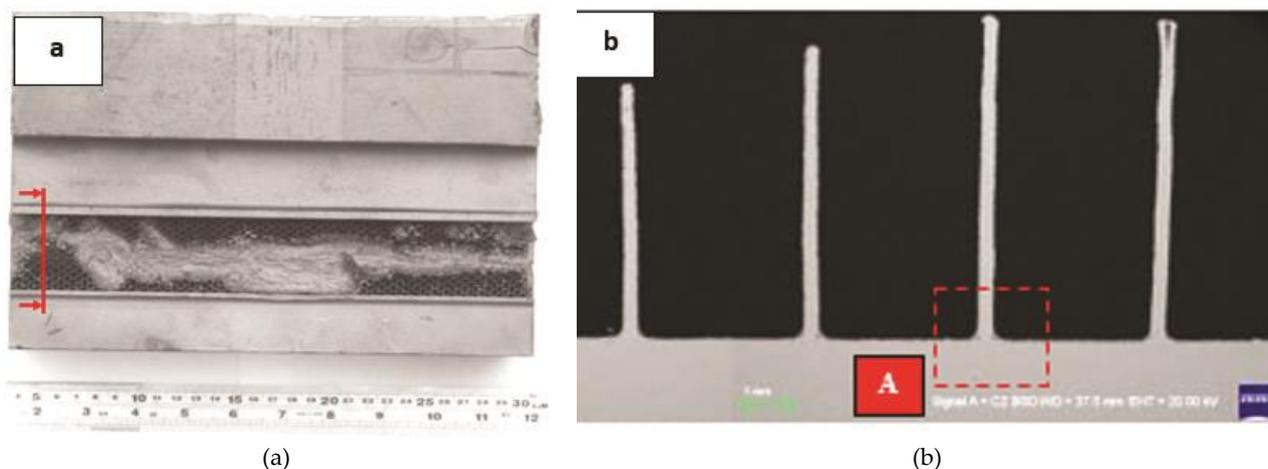
Fig. 6. a) Location of the sample cut for testing; b) location of the honeycomb seal wall joint with the substrate further analyzed

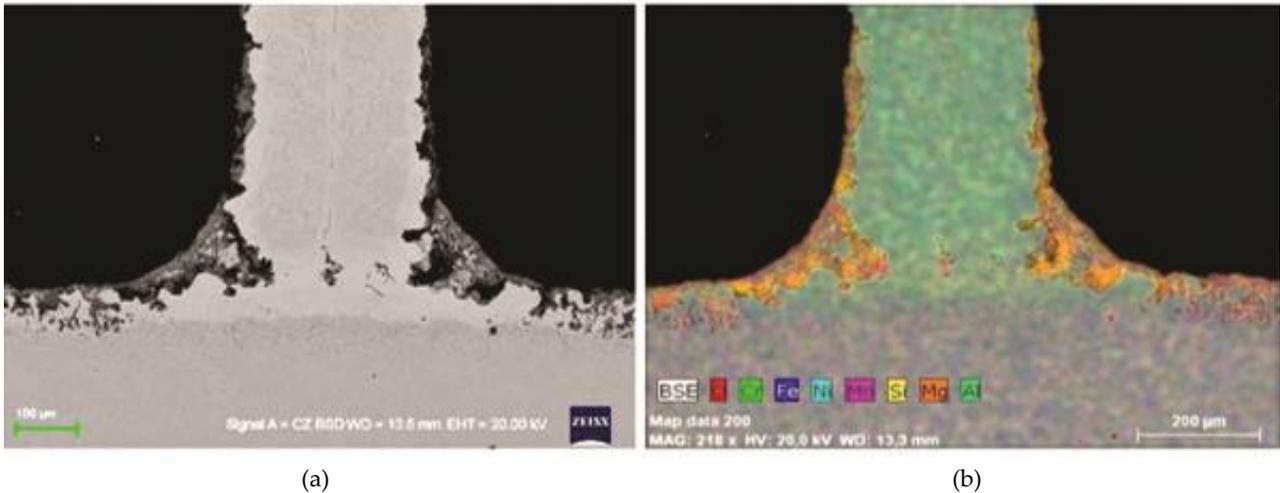
Fig. 7. SEM (BSE) image of a brazed joint: a) distribution of elements on the cross-section of a braze joint; b) between the honeycomb seal and the surface of the shroud

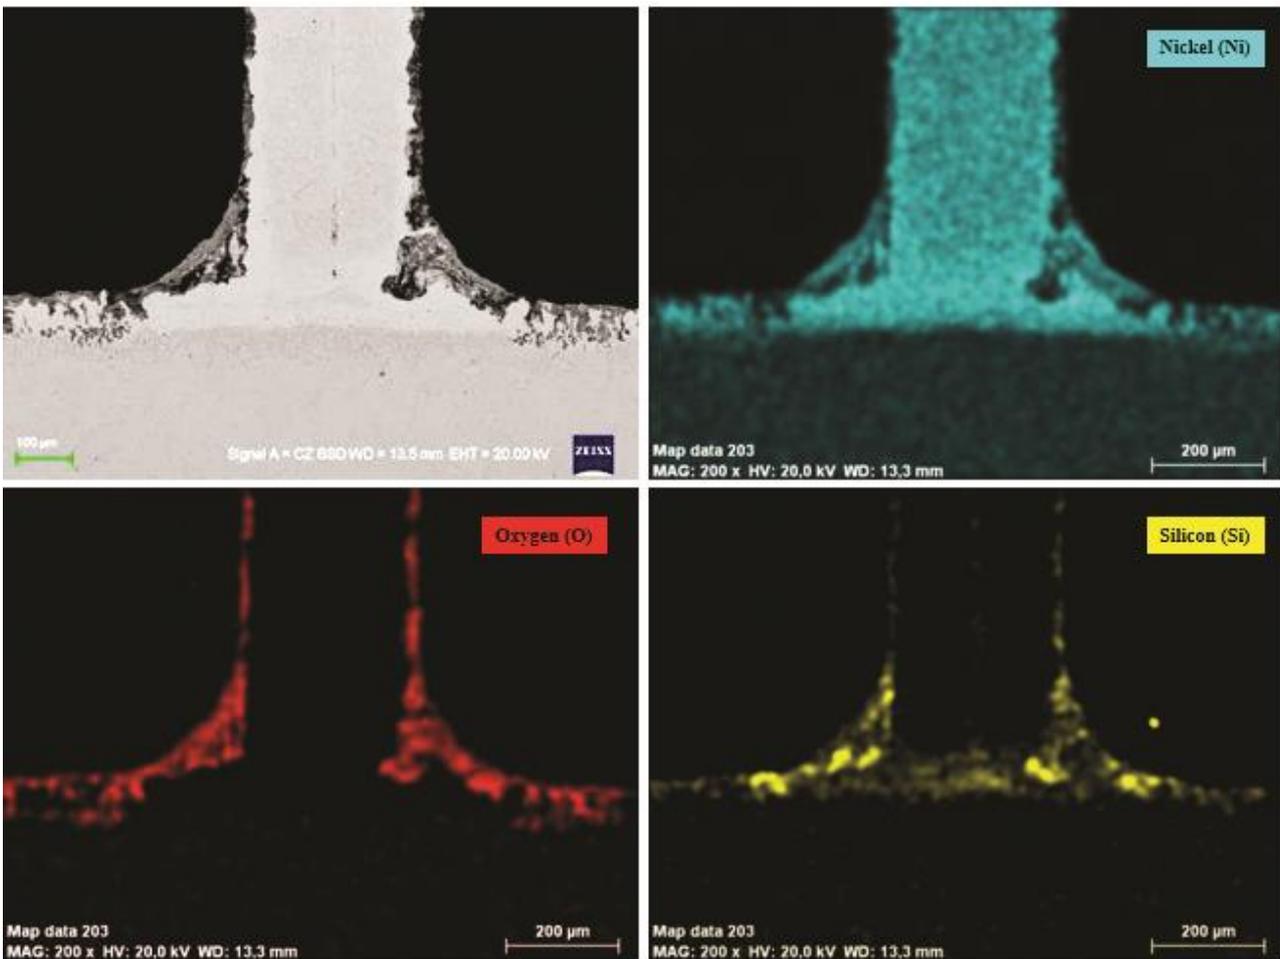
Fig. 8. The surface distribution of O, Si, Ni on the cross-section of the joint of the brazed honeycomb seal with the surface of the shroud

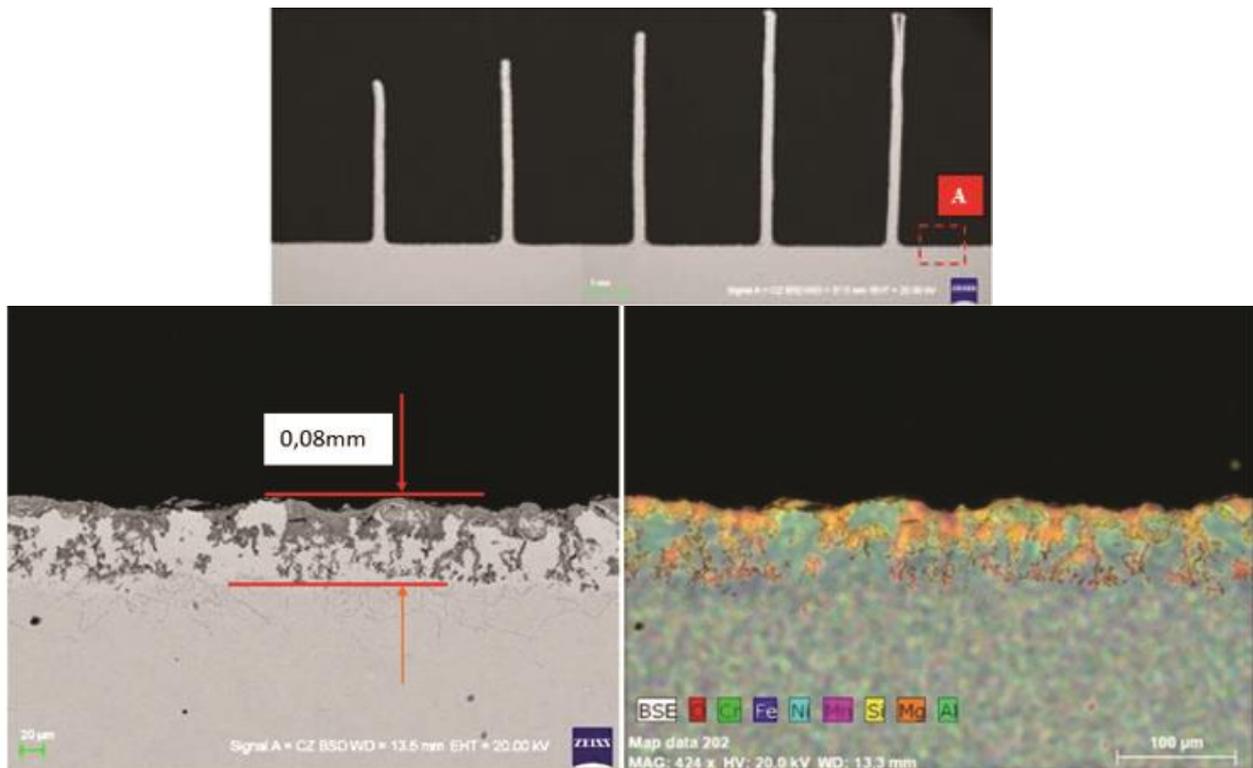
Fig. 9. a) SEM BSE image of the braze joint; b) distribution of chemical elements

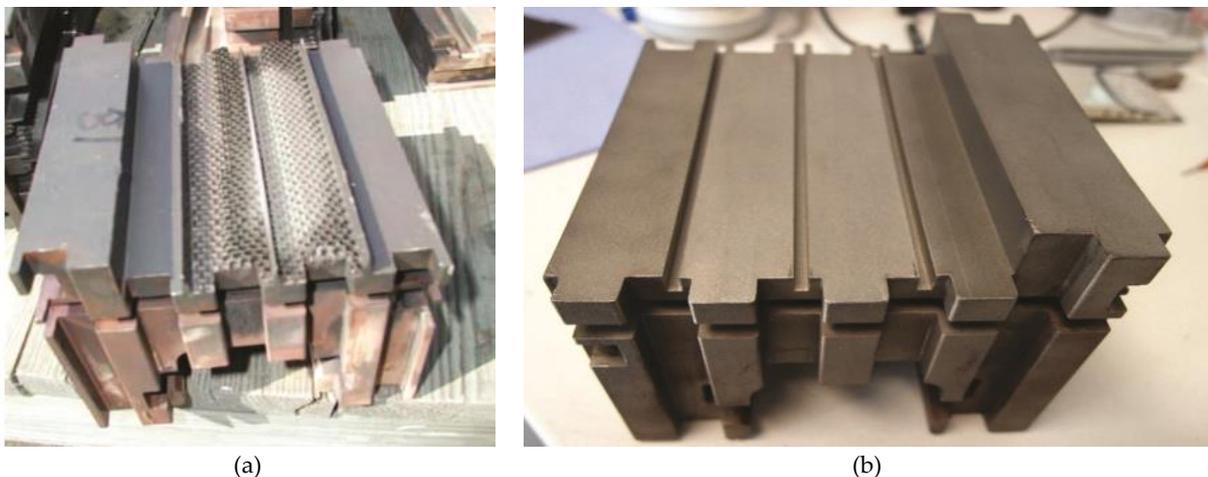
Depending on the operating conditions of the gas turbine and, consequently, the size of the damage to the parts, the repair of the blade shroud may be limited only to replacing the honeycomb seals and restoring the material properties of the parts by carrying out appropriate heat treatment. An example of a segment of the rotor's blade shroud after operation in a turbine is shown in Figure 10a. It happens, however, that the teeth of the labyrinth seal also require rebuilding of the edges or complete rebuilding of their surface as a result of wear, in particular as a result of high-temperature oxidation or friction. The most common method of repairing such wear is manual welding using the TIG process, but due to the large degradation of the base

Fig. 10. Second stage turbine rotor blade shroud segment: a) after operation [10]; b) after preparing the surface for brazing labyrinth and honeycomb seals

material and the rapid overheating of the thin edge of the labyrinth seal, this process is characterized by a large number of defects, mainly in the form of cracks, and thus, requires repair of welds. As an alternative to the time-consuming welding process, it was proposed to use the technology of replacing the teeth of the labyrinth seal using the high-temperature brazing process and the use of a single brazing cycle, during which both the labyrinth and honeycomb seals are joined to the surface of the rotor's blade shroud. The next steps of this repair technology are shown in figures 10b÷12. During the process of removing the old honeycomb seal, grooves are prepared on the same CNC machine, which are milled in the place of damaged teeth of the labyrinth seal. In this place, new teeth are installed, previously made of the same material as the blade's casing, or of a material with better properties, mainly better resistance to high-temperature corrosion. The next step is to install honeycomb seals which are previously impregnated with brazing tape and then pre-fix them prior to the brazing process using a resistance welding process. At the connection of the teeth of the labyrinth seal with the surface of the blade shroud, a brazing paste of the same composition as the tape used in the honeycomb seal is additionally applied, and the entire area around the elements to be joined is masked with stop-off paste, which prevents braze from flowing into undesirable places.

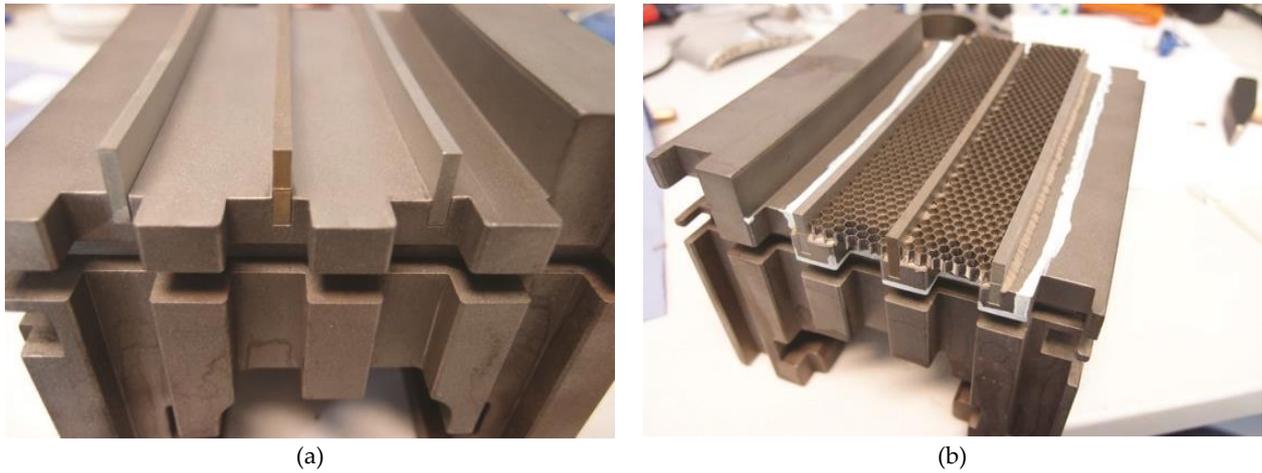
Fig. 11. a) Assembly of the labyrinth seal teeth in the blade shroud; b) blade shroud with honeycomb seals fitted and brazing paste and stop-off paste applied

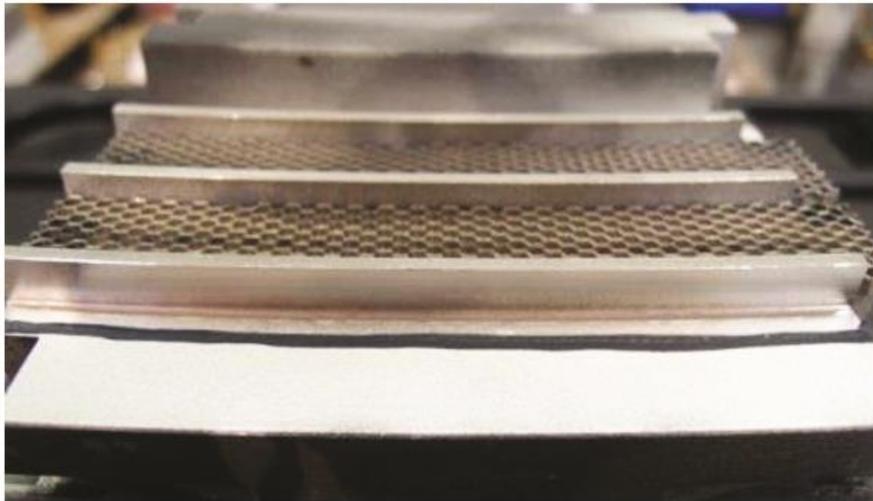
Fig. 12. Blade shroud after the high temperature brazing

The parts are then subjected to a high-temperature brazing process in a vacuum furnace. Photos of the parts after brazing are shown in figure 12. In the next step, all the braze joints are visually inspected, while braze joints of honeycomb seals are additionally visually inspected using a borescope to assess continuity. Visual and borescope examinations are performed based on the company's internal specifications. The visual inspection of the braze joints did not reveal any braze incompatibilities and ended with a positive result. As part of the qualification of the first piece of the new repair process, one of the segments was subjected to destructive testing to assess the quality of the brazed joint of the seal and the surface of the blade shroud.

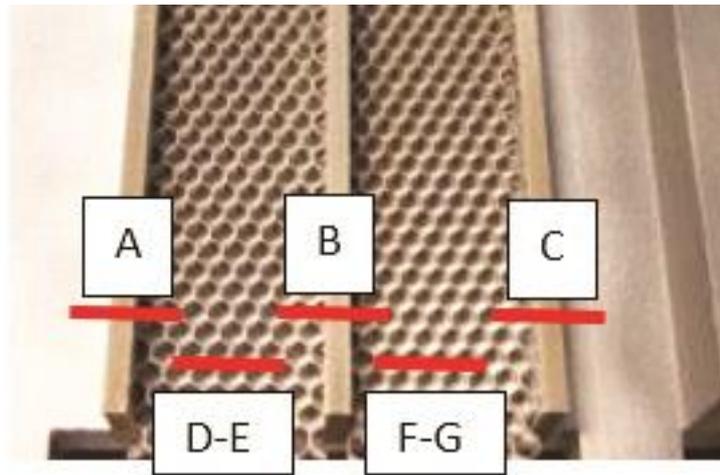
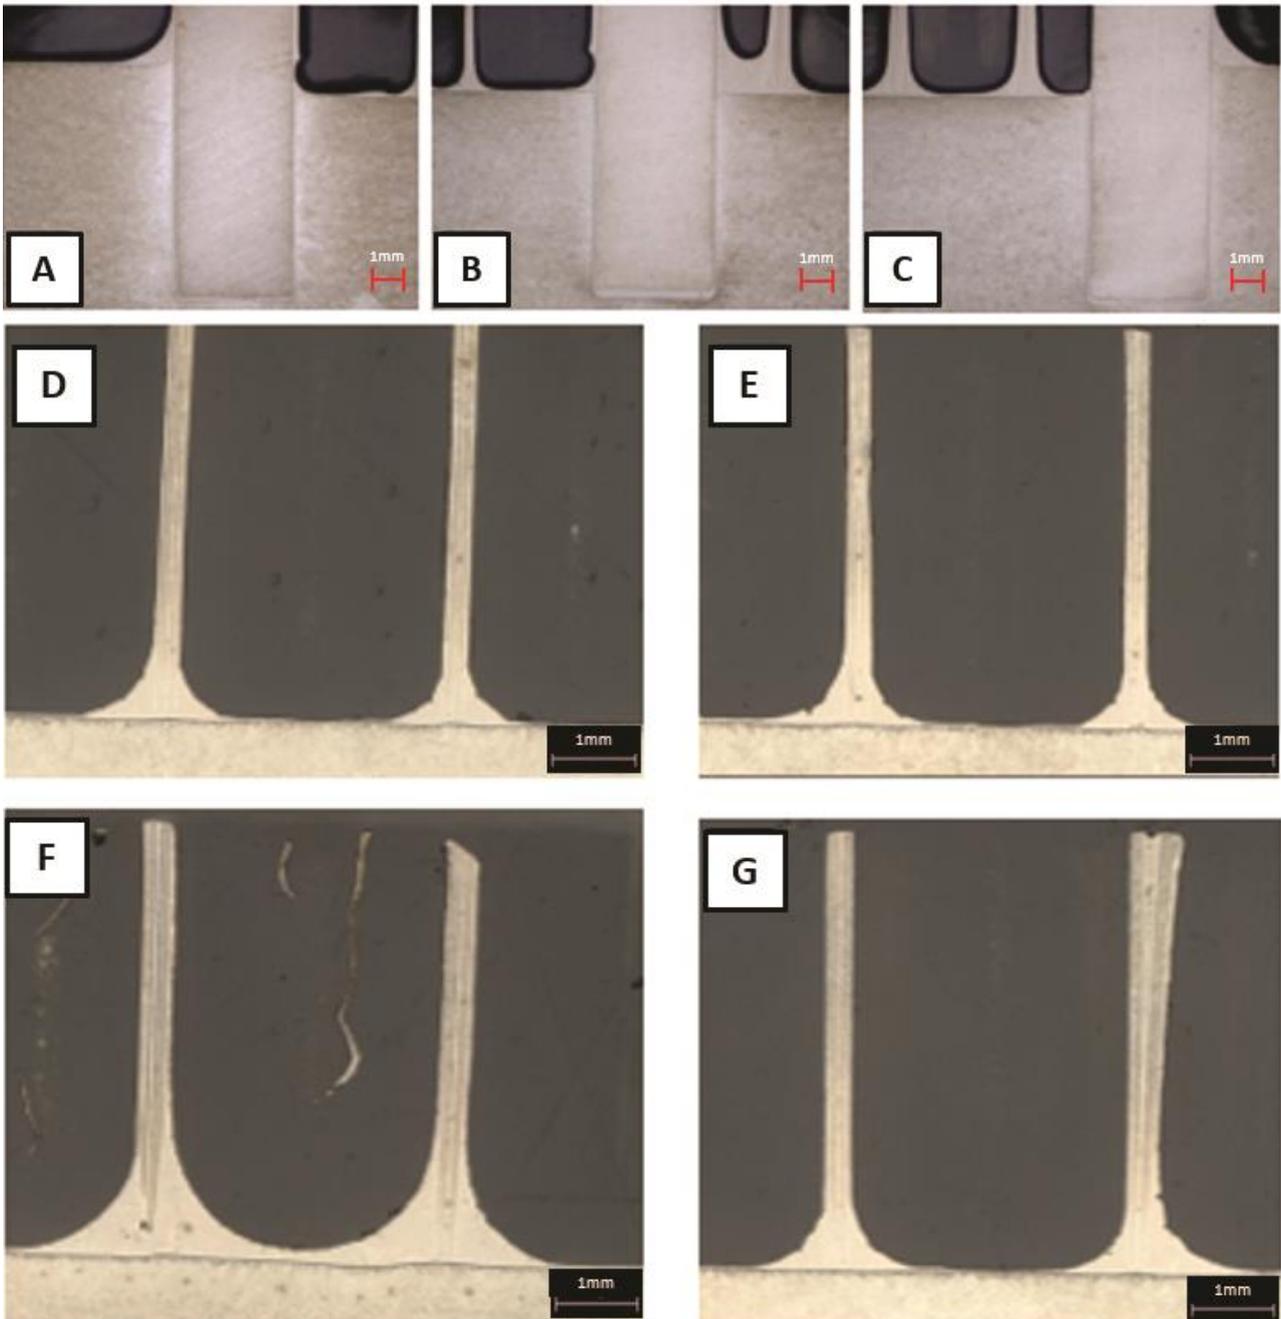
Figure 13 shows the cross-sections of the brazed elements made using a light microscope. Both the braze joint between labyrinth seals and honeycomb seals and the surface of the blade shroud complies with the quality requirements, free from any defects in the form of voids, cracks, porosity or linear eutectics that could weaken the strength of such a joint. We can observe the correctly selected width of the brazing gap for the teeth of the labyrinth seal (A-C), which allowed for an appropriate capillary action allowing the gap to be completely filled with braze. The amount of brazing paste used was sufficient for both seals, which is important especially in the case of honeycomb seals, in which the total filling of the cell with braze cannot exceed 25% of the seal's height (D-G).

Fig. 13. Microstructure of brazed joints between the blade shroud and honeycomb and labyrinth seals
